Manhole Inspection Summary

Manhole # S37G__006MH

Insp Date: **8/18/08 12:06 PM**

Location Address: **600 e baltimore st**

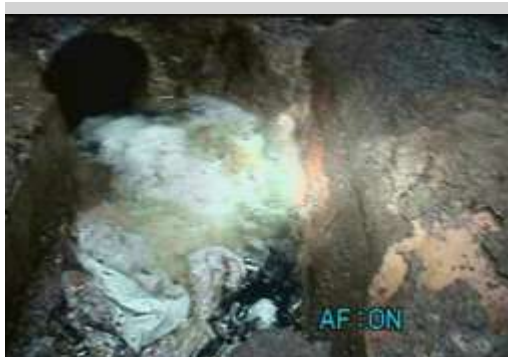
Defect 3

Condition: ☐ Sound ☐ Cracked ☐ Root Intrusion ☐ Deteriorated ☐ Leaks ☒ **Debris**

channel debris

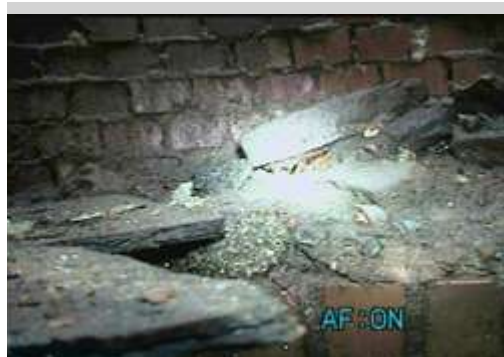
Defect 2

Condition: ☐ Sound ☐ Cracked ☐ Root Intrusion ☐ Deteriorated ☐ Leaks ☒ **Debris**

bench debris

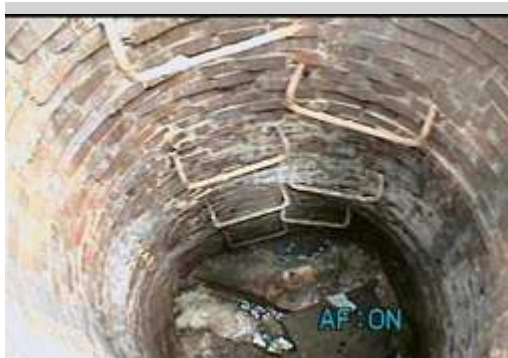
Defect 1

Steps Count: **7** Missing: **0** ☒ **Corroded**

steps

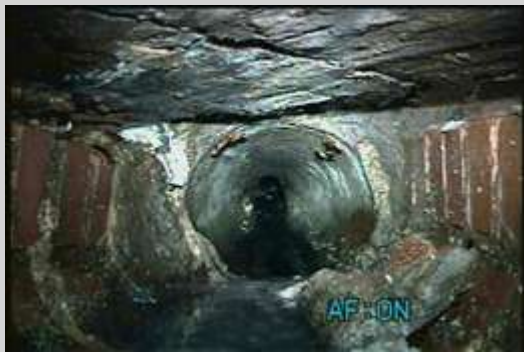
12 O'Clock Outflow

10 in. Circular Gravity Sewer
Pipe Out @ 12 O'Clock

Deposits: ☒ None ☐ Mud ☐ Sludge ☐ Debris ☐ Grease

Infiltration: **None** Pipe Seal Cond: **Unknown**

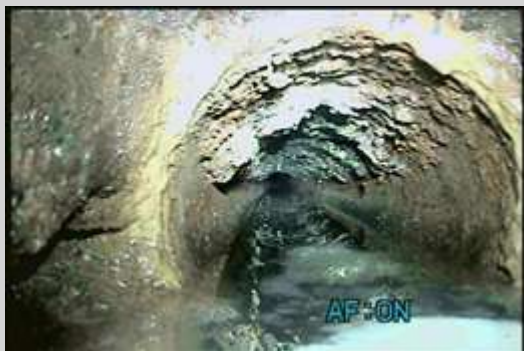
5 O'Clock Inflow

10 in. Circular Gravity Sewer
Pipe In @ 5 O'Clock

Deposits: ☒ None ☐ Mud ☐ Sludge ☐ Debris ☐ Grease

Infiltration: **None** Pipe Seal Cond: **Unknown**
